TECHNICAL REPORT HL-92-1

BRUSH CREEK, KANSAS CITY, MISSOURI

Hydraulic Model Investigation

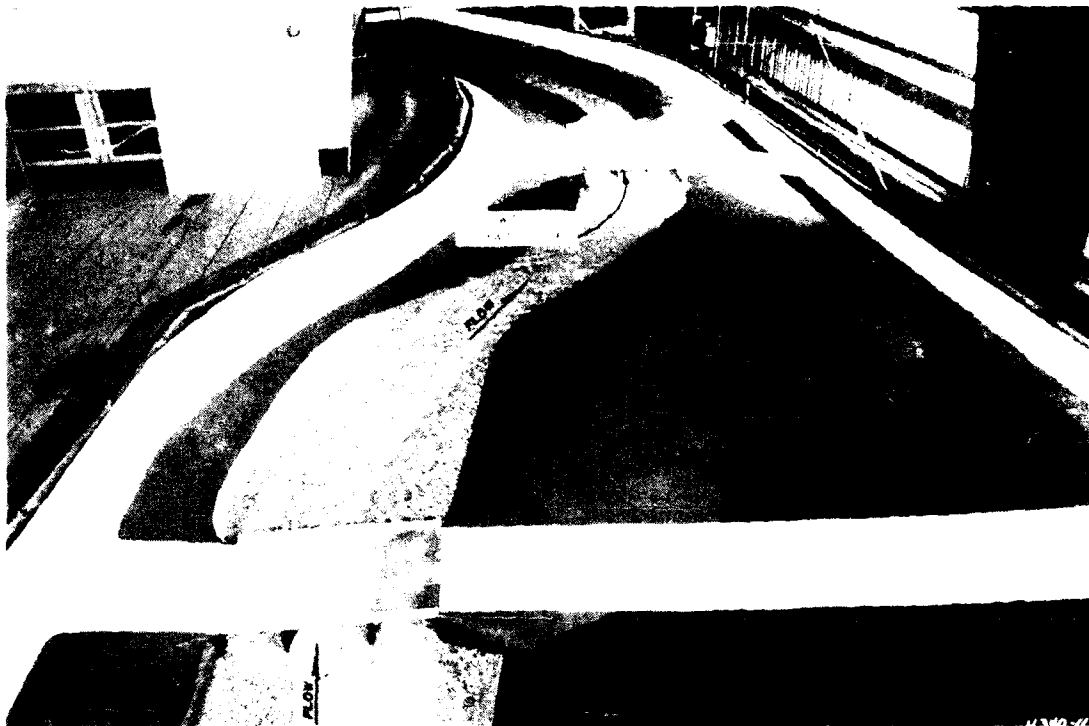
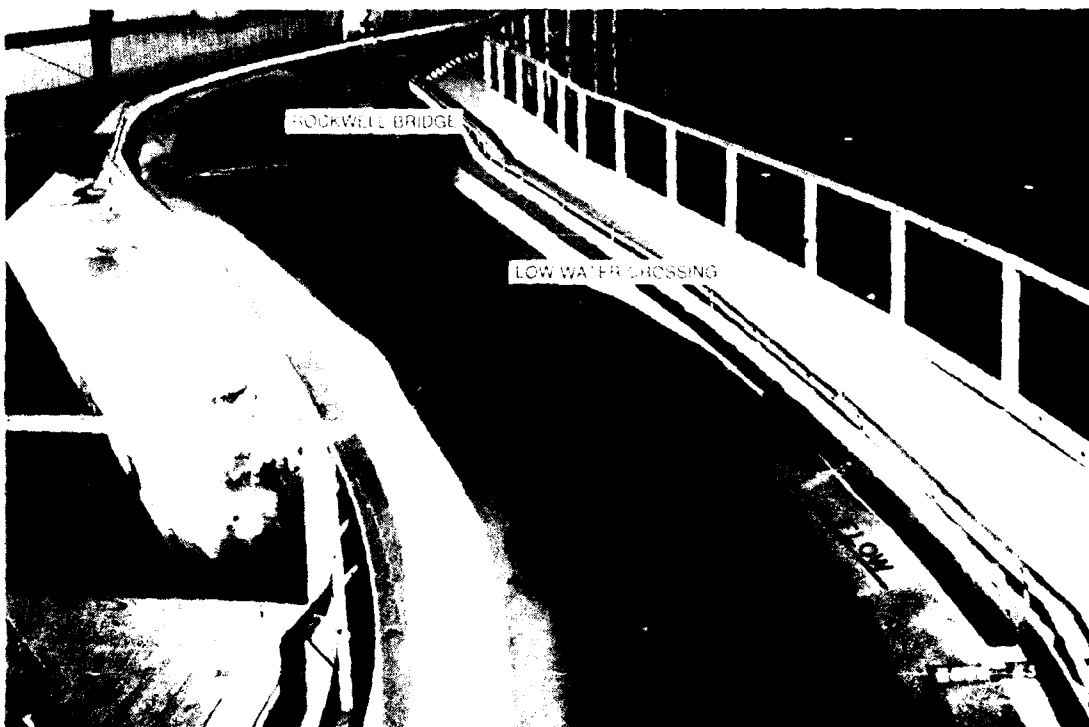
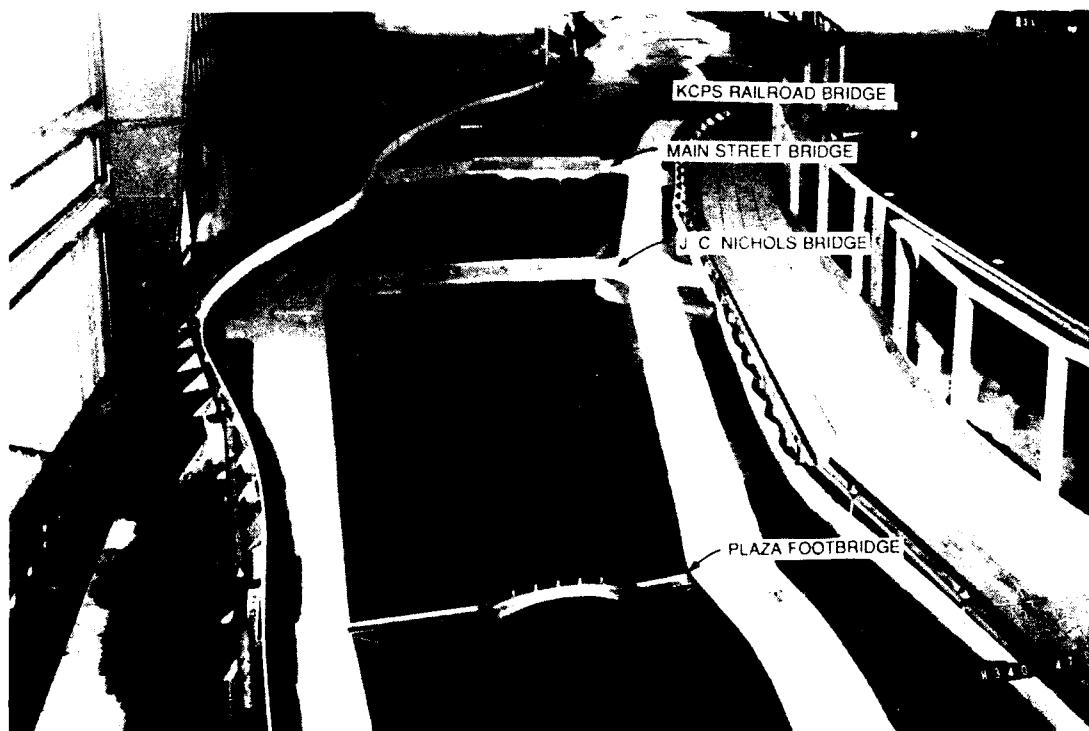
Photo 5. Existing conditions, 10-year flood (Sheet 1 of 4)

a. Sta 0+00 to sta 15+00

b. Sta 14+00 to sta 37+00

c. Sta 35+00 to sta 61+00

d. Sta 61+00 to sta 81+00

e. Sta 81+00 to sta 112+00

f. Sta 112+00 to sta 147+00

g. Sta 135+00 to sta 147+00

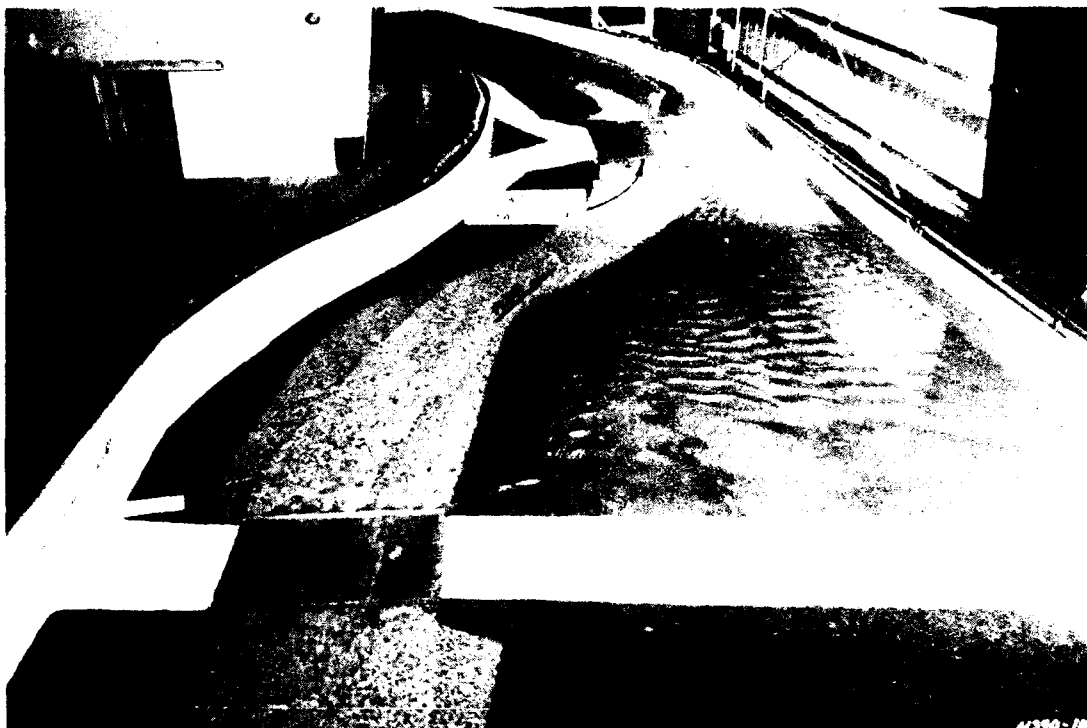
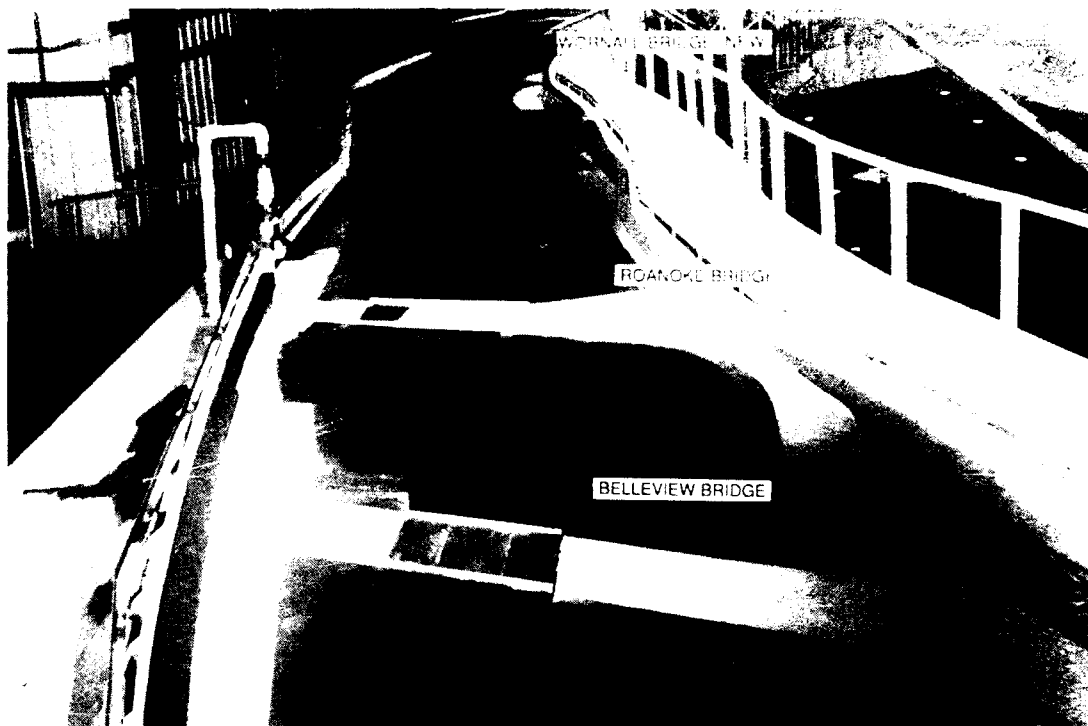
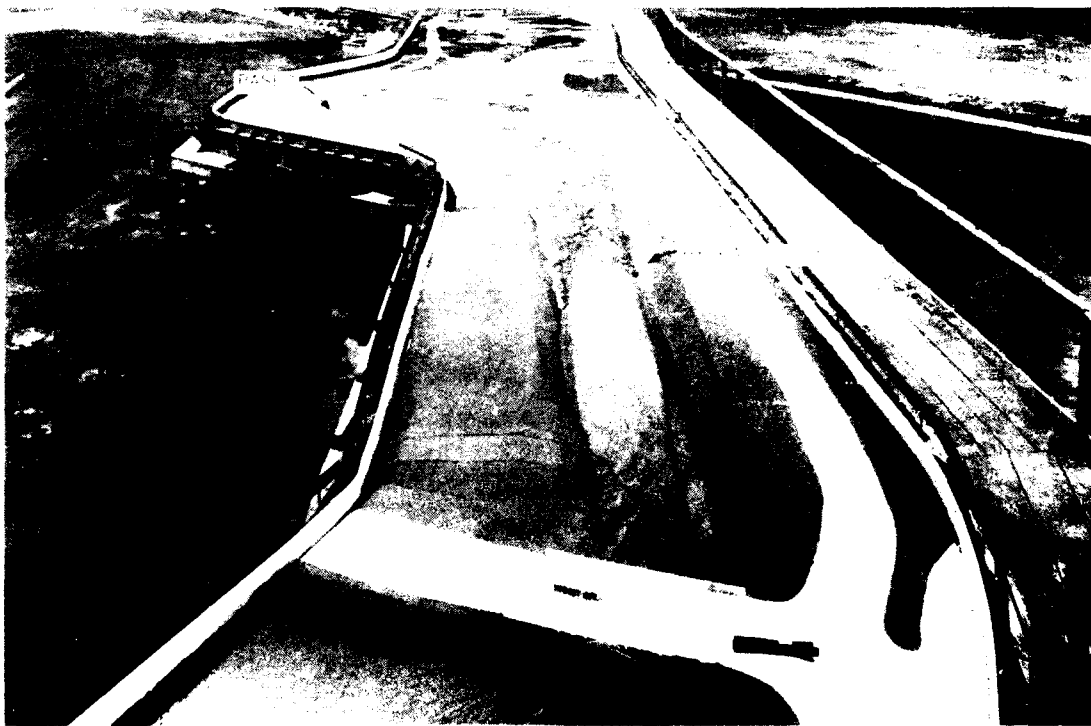
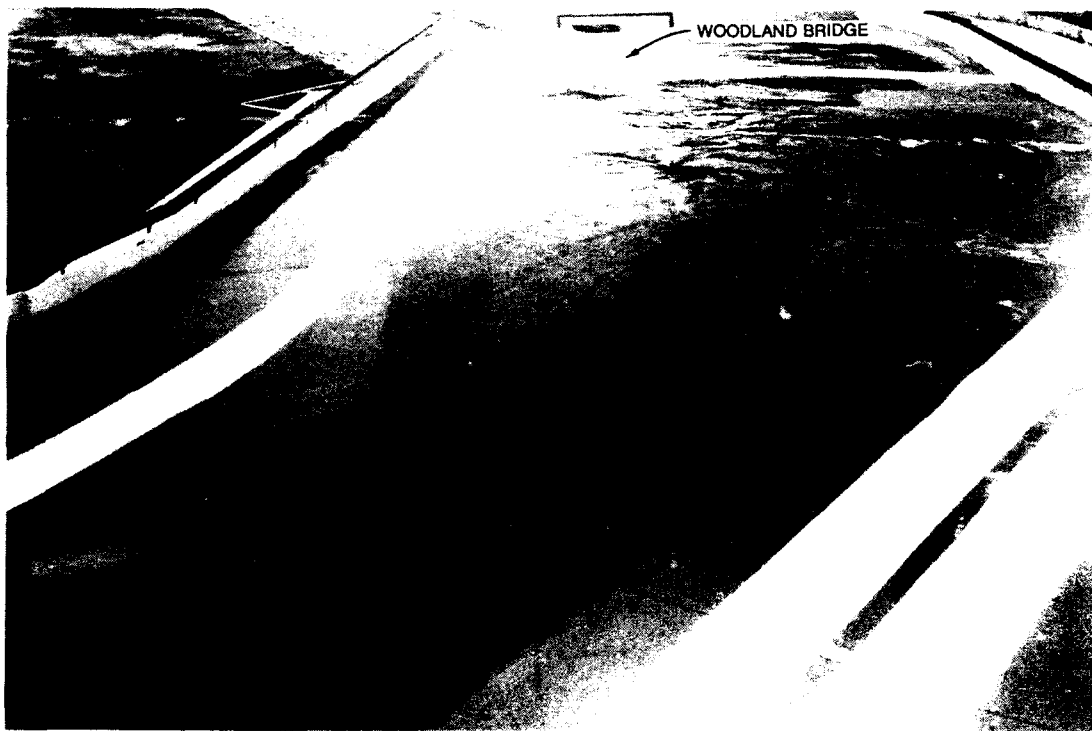
Photo 6. Existing conditions, 100-year flood (Sheet 1 of 4)

a. Sta 0+00 to sta 15+00

b. Sta 14+00 to sta 37+00

c. Sta 35+00 to sta 61+00

d. Sta 61+00 to sta 81+00

e. Sta 81+00 to sta 112+00

f. Sta 112+00 to sta 147+00

g. Sta 135+00 to sta 147+00

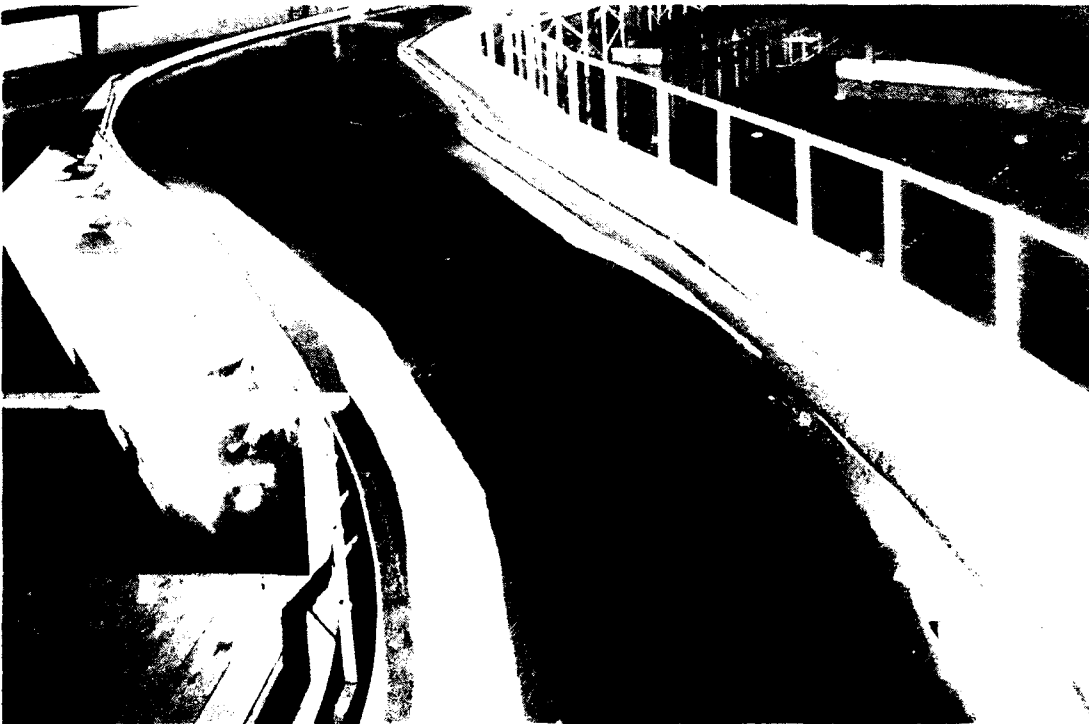
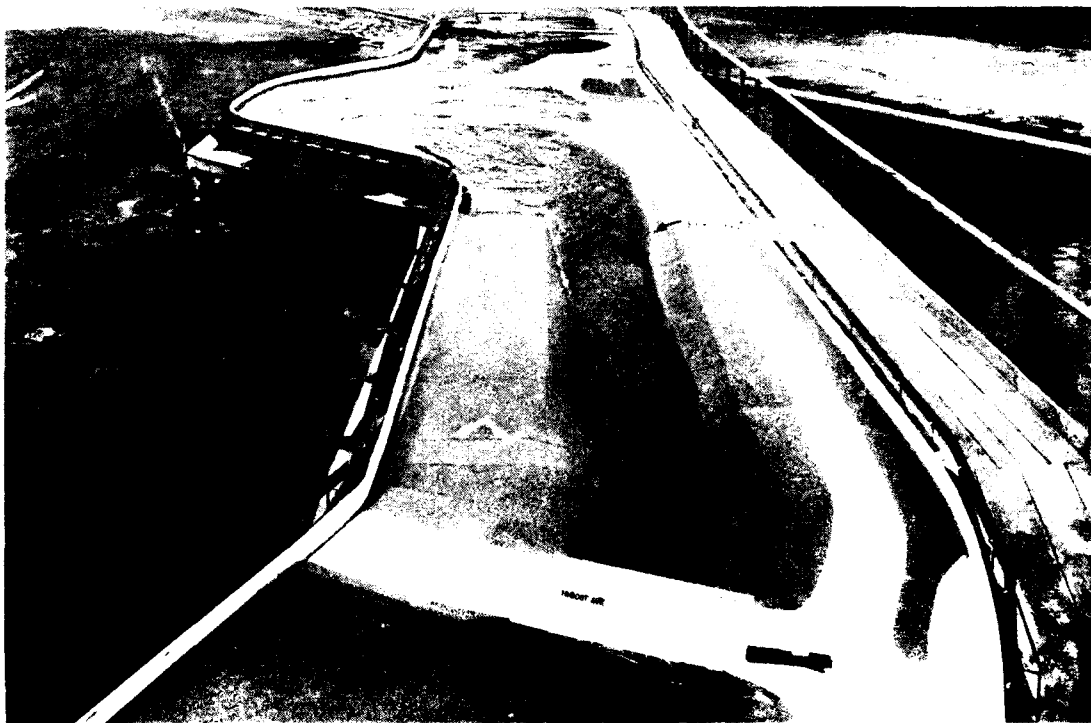
Photo 7. Existing conditions, 500-year flood (Sheet 1 of 4)

a. Sta 0+00 to sta 15+00

b. Sta 14+00 to sta 37+00

c. Sta 35+00 to sta 61+00

d. Sta 61+00 to sta 81+00

e. Sta 81+00 to sta 112+00

f. Sta 112+00 to sta 147+00

g. Sta 135+00 to sta 147+00

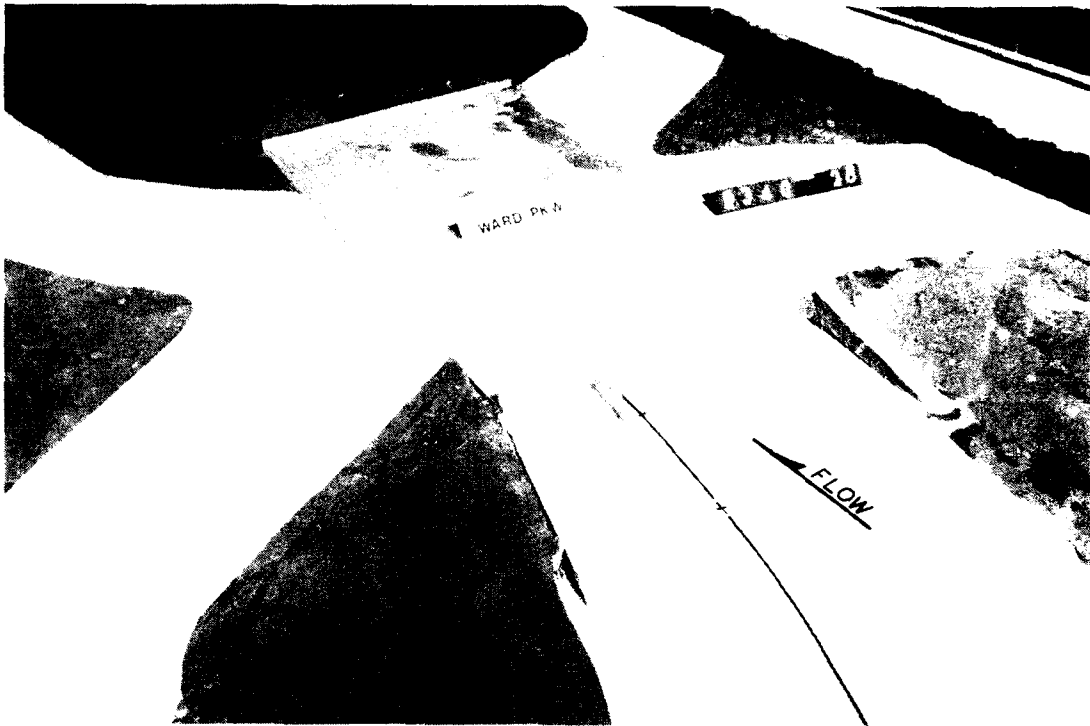
Photo 8. Ward Parkway Bridge

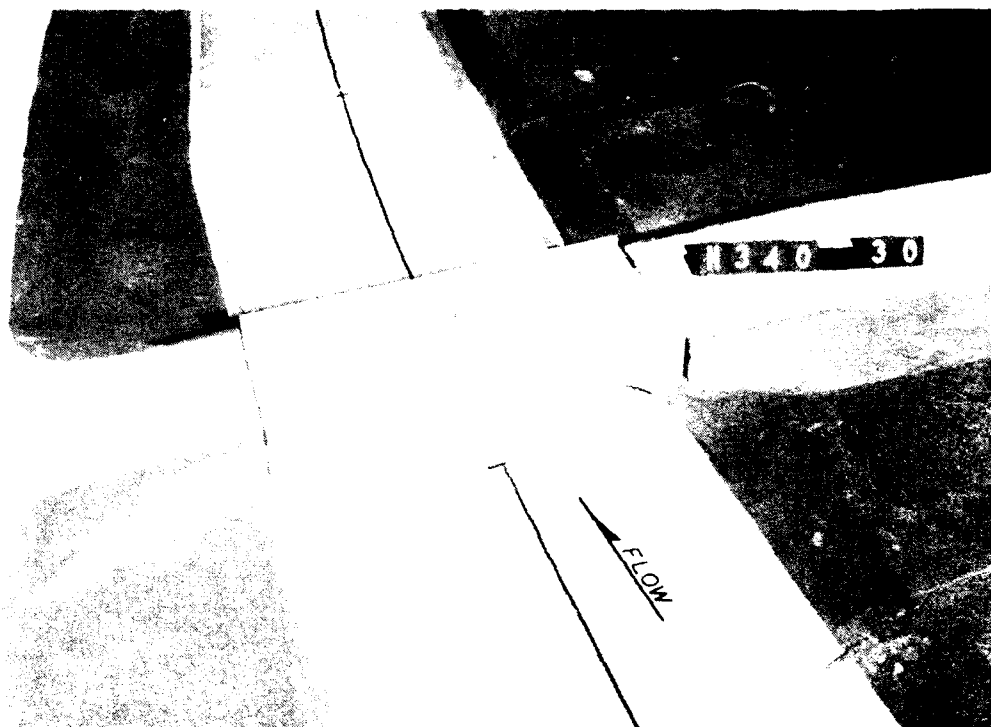
Photo 10. Rockwell Road Bridge (existing) (50th Street)

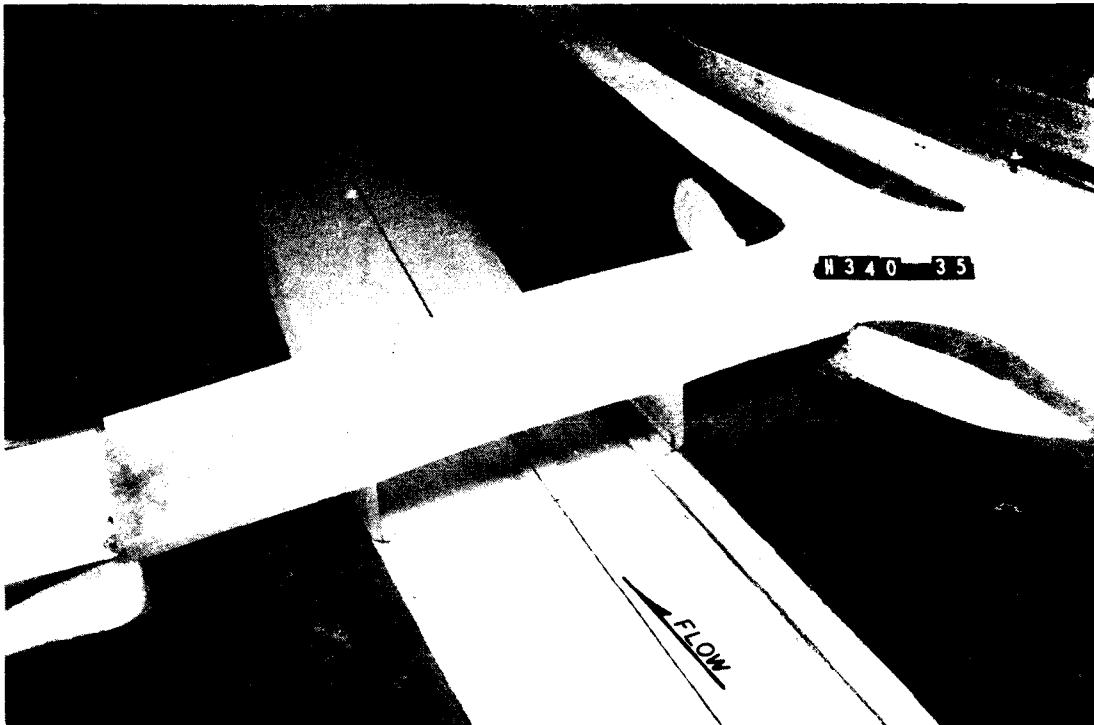
Photo 14. J. C. Nichols Parkway Bridge

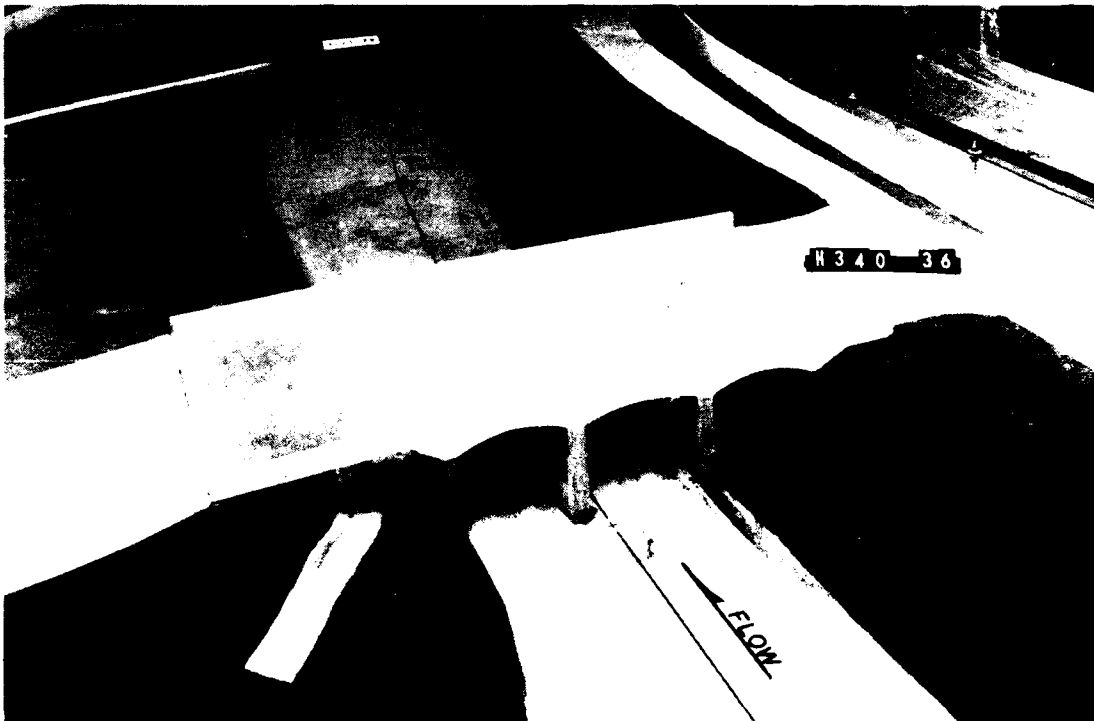
Photo 15. Main Street Bridge

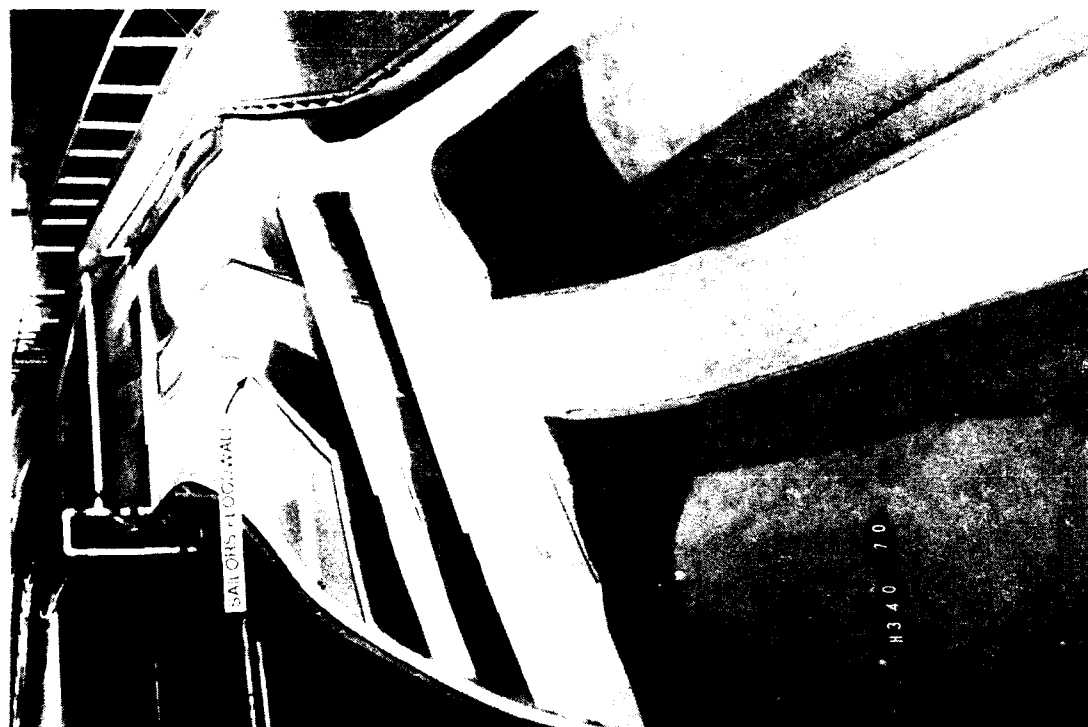
a. Sta 39+00 to sta 70+00

b. Sta 70+00 to sta 94+00

Photo 22. Corps BCP-9 Plan (Continued)

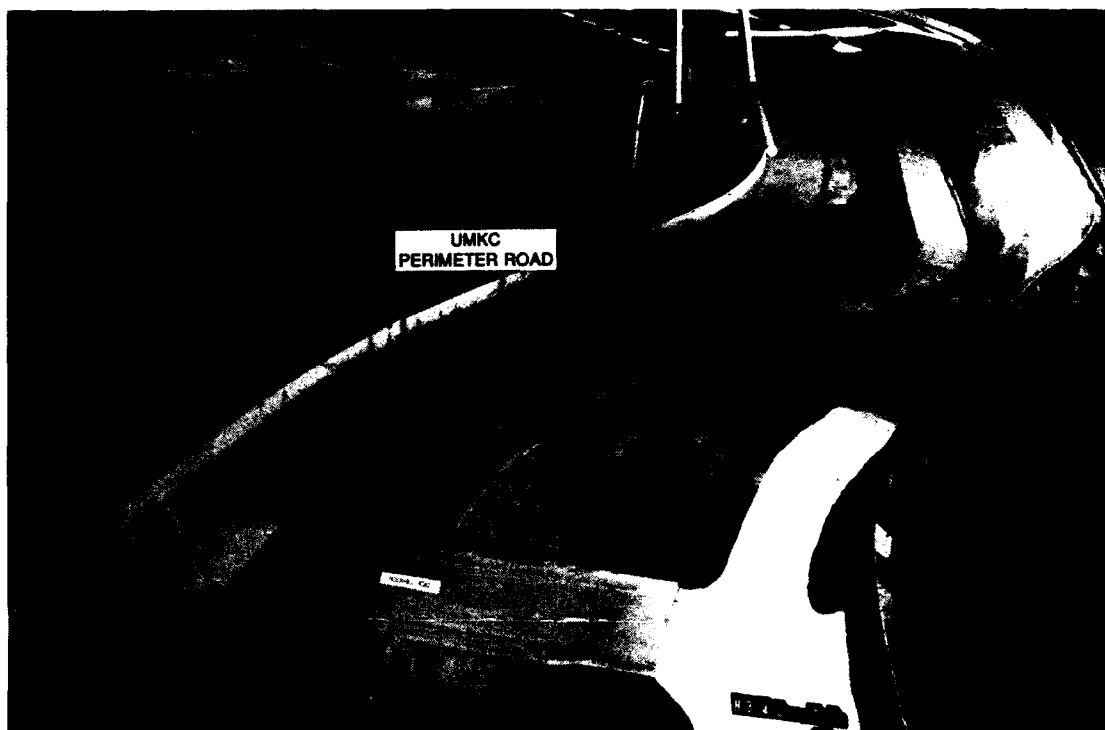
c. Sta 94+00 to sta 114+00

Photo 22. (Concluded)

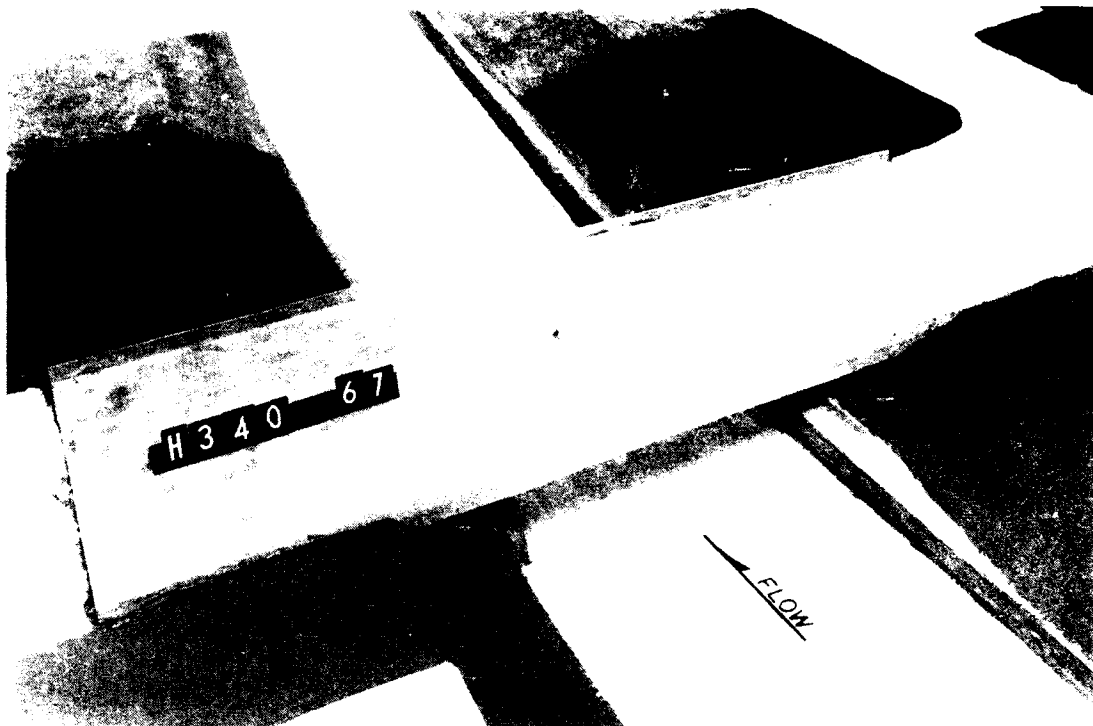
Photo 23. Oak Street Bridge (new)

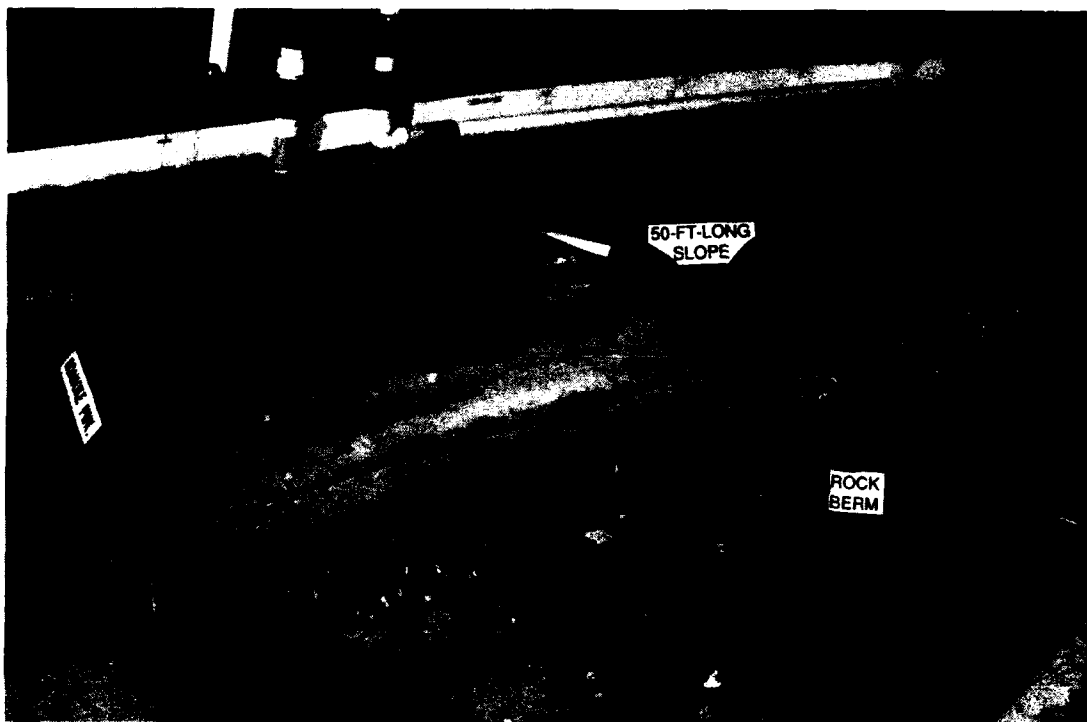
Photo 33. Rock berm in vicinity of 50-ft-long slope

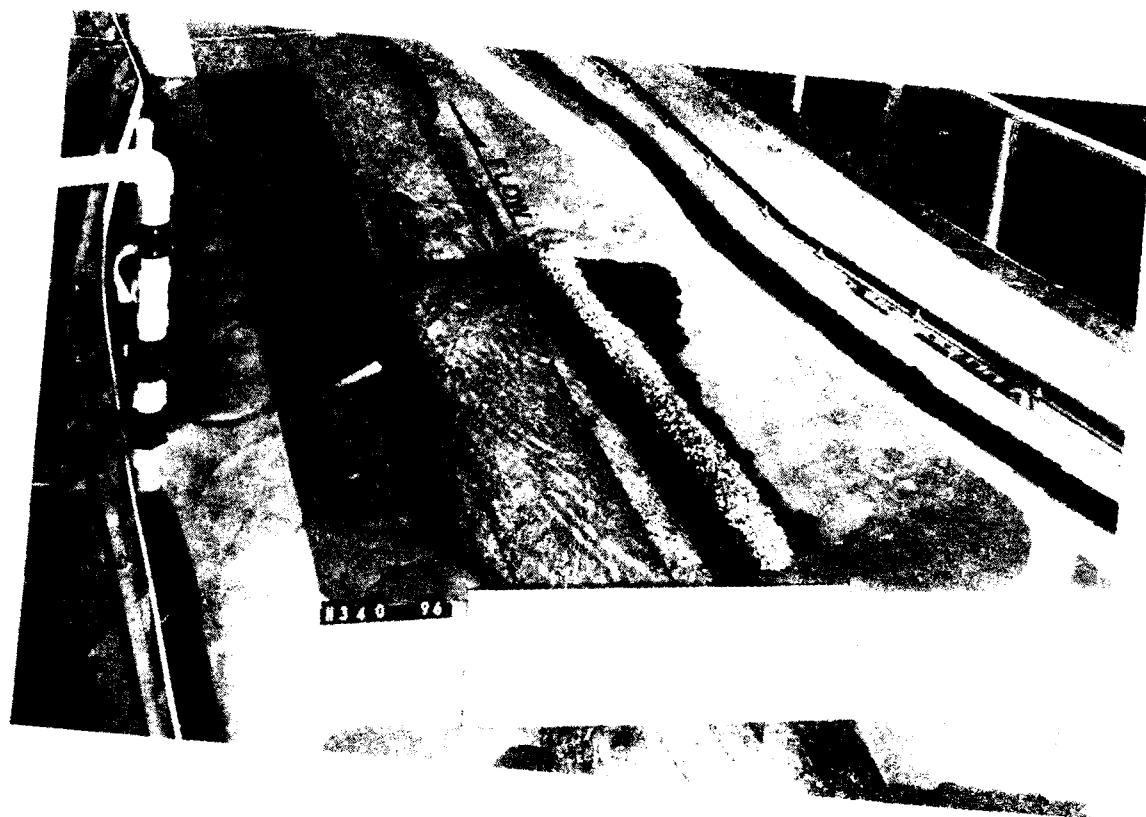
a. 10-year flood

b. 500-year flood

Photo 34. Flow conditions at 50-ft-long slope transition with rock berm

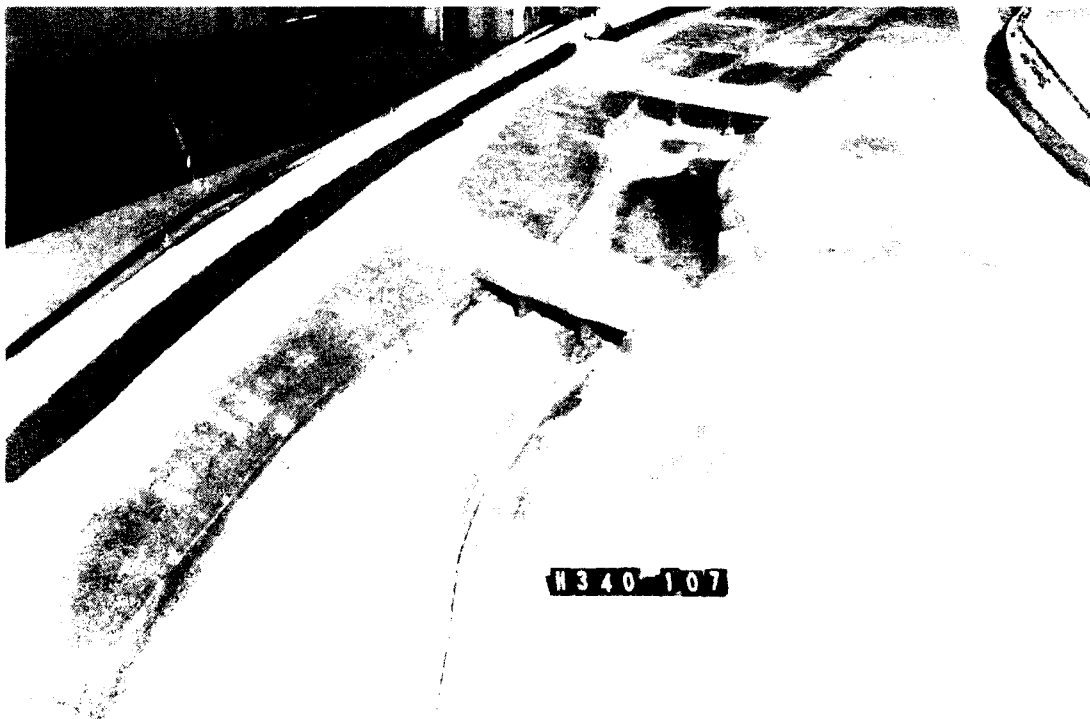
a. Sta 20+00 to sta 31+00

b. Sta 34+00 to sta 40+00

Photo 35. City upstream plan

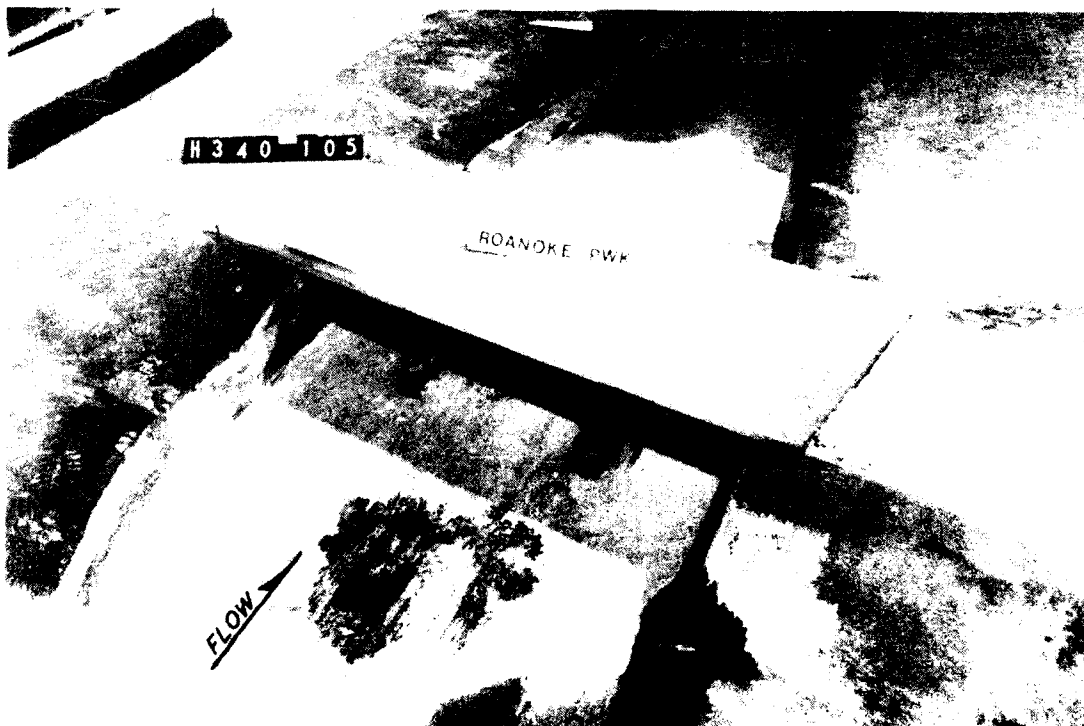
a. Belleview Avenue Bridge

b. Roanoke Parkway Bridge

Photo 36. City upstream deepening modification

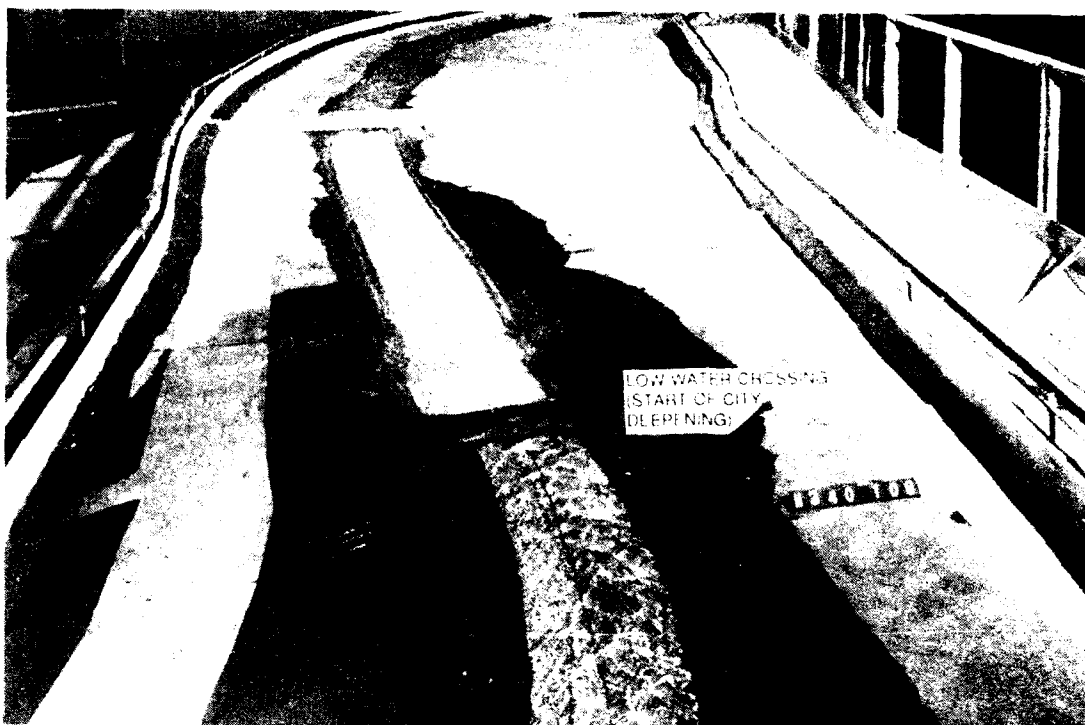
a. Sta 18+00 to sta 36+00

b. Sta 31+00 to sta 40+00

Photo 37. City upstream deepening plan, 10-year flood

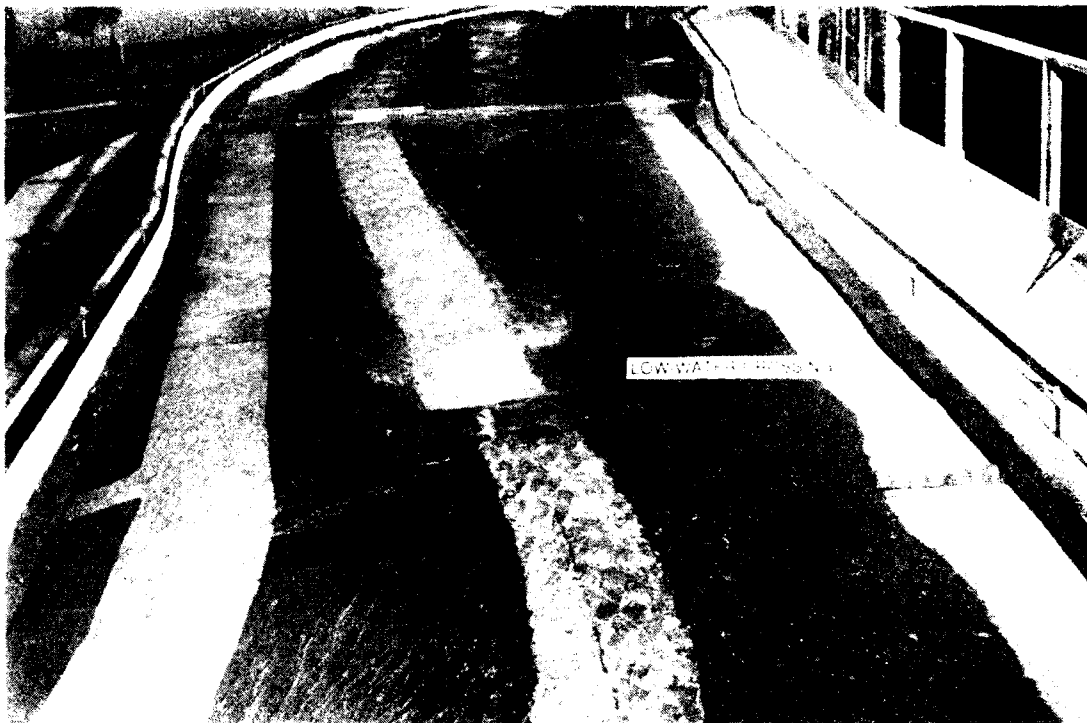
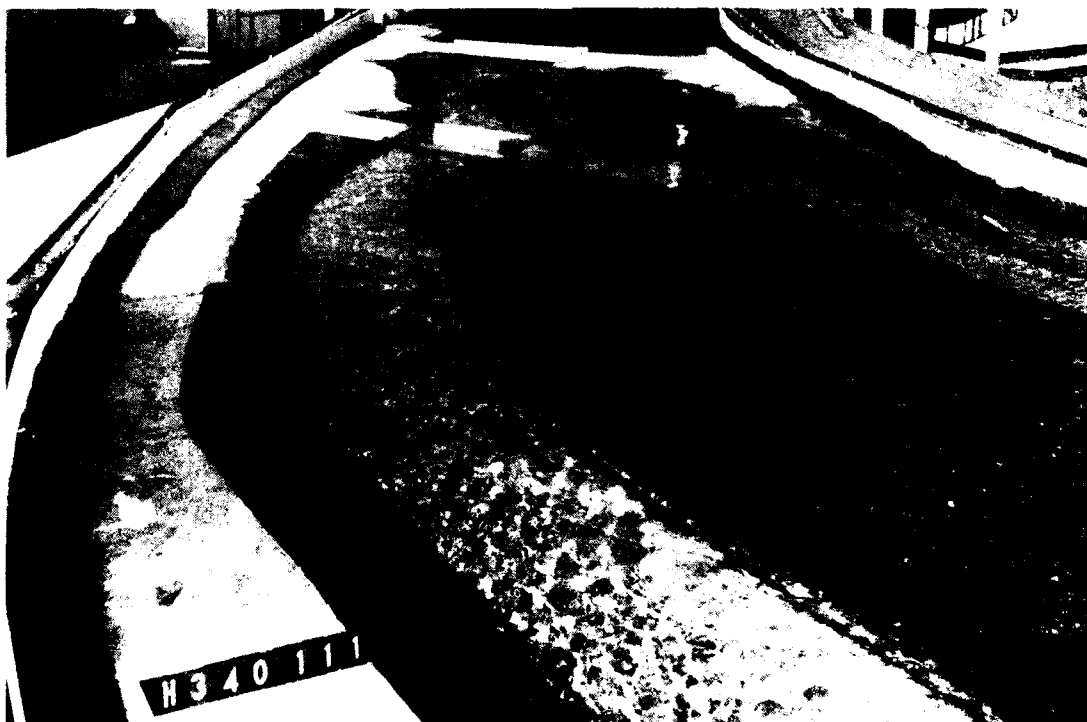
a. Sta 18+00 to sta 36+00

b. Sta 31+00 to sta 40+00

Photo 38. City upstream deepening plan, 500-year flood

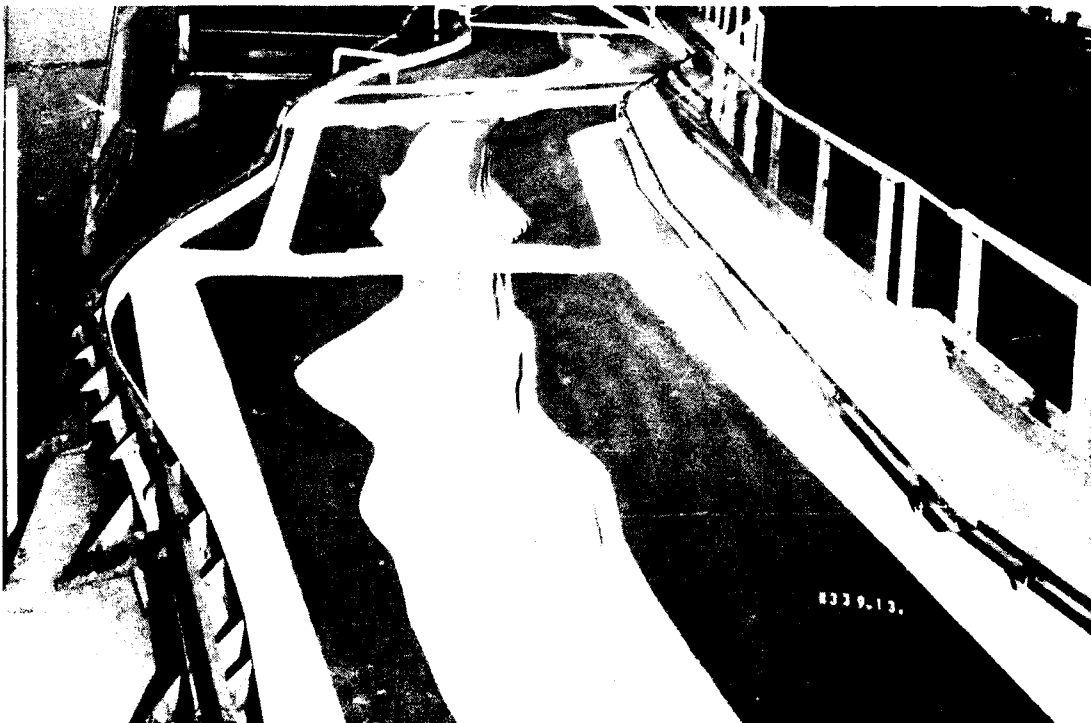
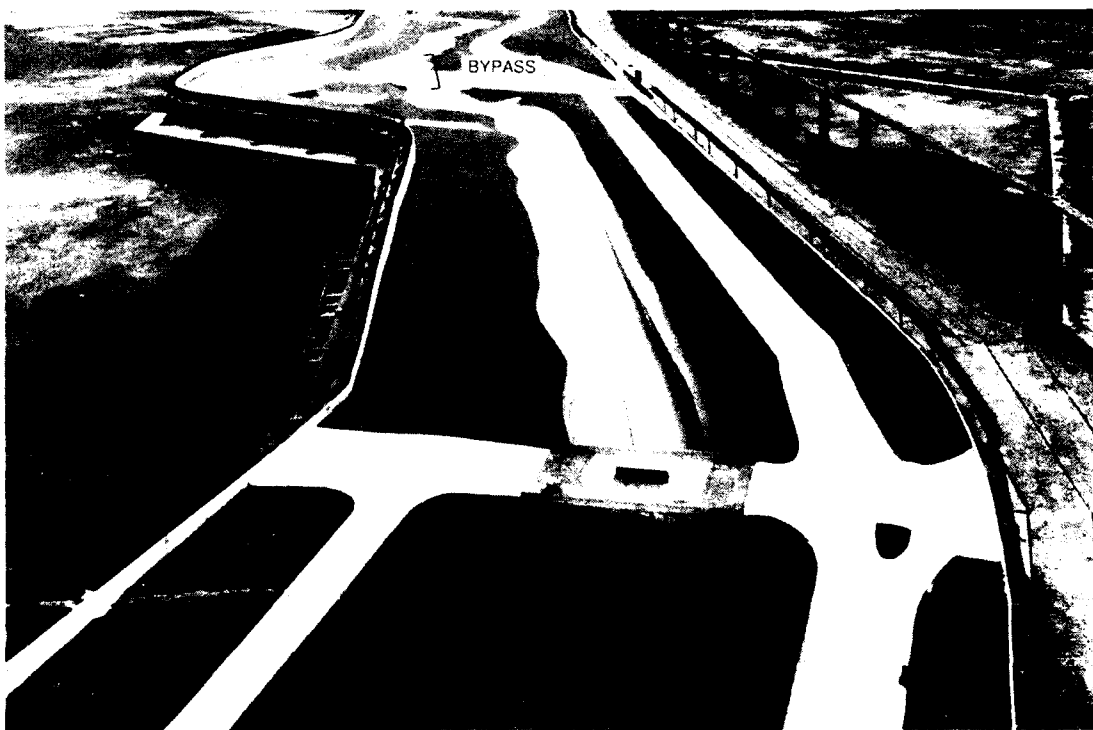
a. Sta 34+00 to sta 65+00

b. Sta 60+00 to sta 84+00

Photo 40. Park Plan (Continued)

c. Sta 81+00 to sta 112+00

d. Sta 112+00 to sta 147+00

Photo 40. (Concluded)

turned the flow some 90 deg, and flooding frequently occurred (Photos 5f, 6f, and 7f). The Park Plan calls for bypassing the existing tunnel with a straightened open channel (Photo 40d). Two new bridges will span the channel on Paseo Boulevard (Photo 58). Dam 4 initially was to be located under the downstream bridge.

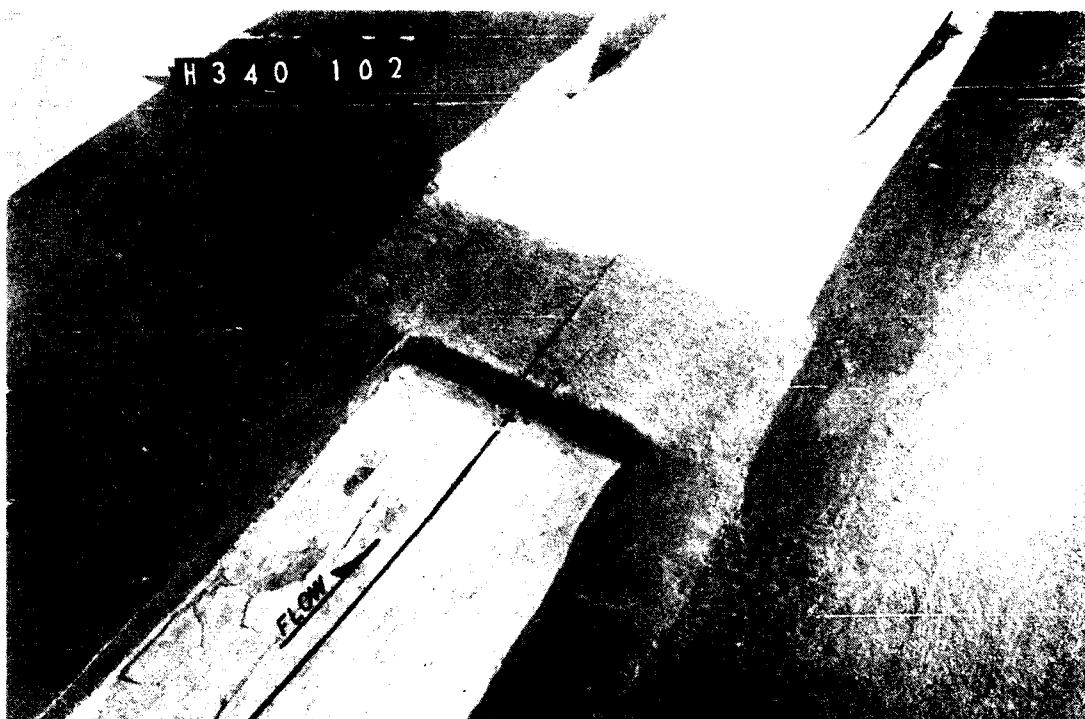
Photo 41. Modification at low-water crossing (51st Street)

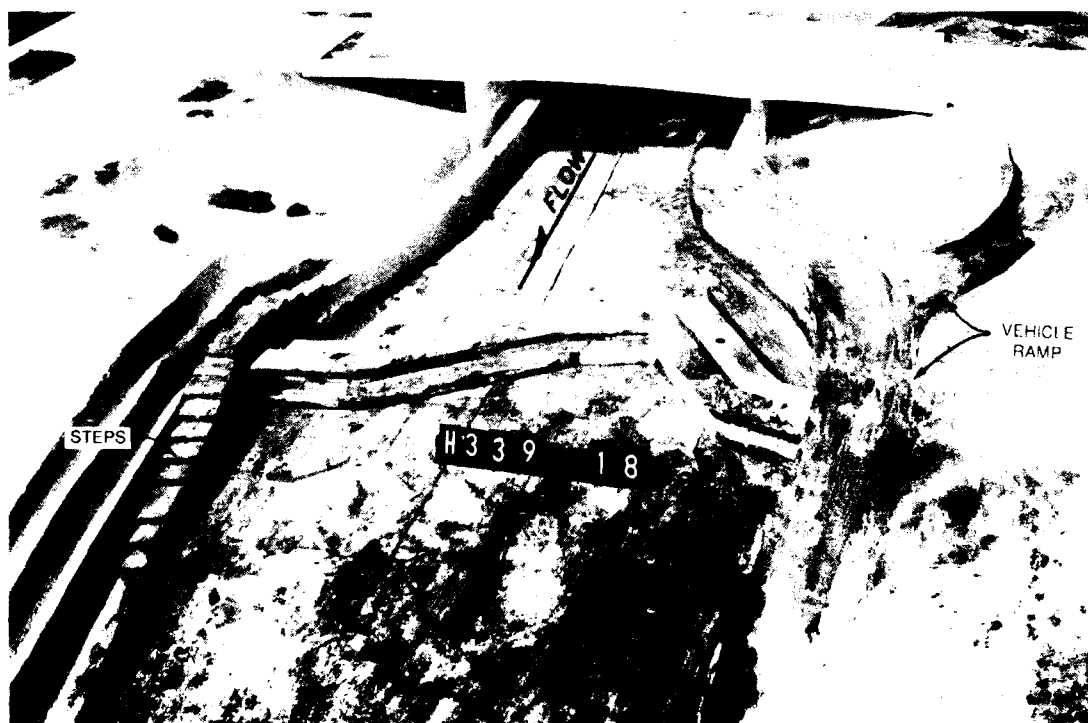
Photo 42. Irregular dam 1, sta 68+65
